Arnold Farm 1440 Bollinger Road

Maryland Historical Trust State Historic Sites Inventory Form

Survey No. CARR-1330

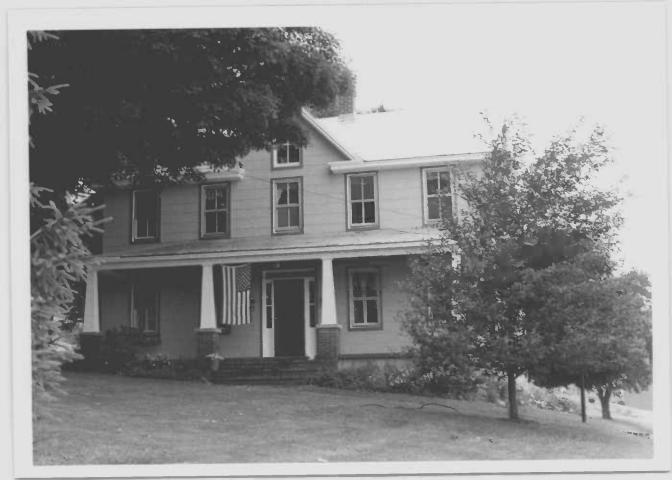
Hrold Farm 1440 Bolliger Rd. Country, maryland Photo: Marcia Wiles Date: June 1993 Neg, Loc. Maryland Historical Trust new house - Southuast elevation 17.

The new house is a 2½-story, five-bay, central-gable I-house with an ell. The house faces southeast. It has a parged foundation, asbestos shingle siding, and a gable roof with metal shingles and a northeast-southwest running ridge. The ell is attached to the north half of the northwest elevation. It also has a gable roof with metal shingles, and the ridge runs northwest-southeast. Both roofs have an aluminum covered box cornice with returns. The southeast elevation has a center entrance with a four-panel door. It has bolection moulded panels, the top two of which are semi-circular. There is

also a two-light transom and sidelights with two lights and a single panel at the bottom of each. On either side of the door are two 2/2 double-hung sash. There is a one-story, five-bay porch with a half-hip roof with metal shingles. It has four battered columns set on brick piers. The second story has five 2/2 sash. There is a central gable dormer with a semi-circular 2/2 sash. There are two interior brick chimneys, each one flanking the center dormer; they have been rebuilt.

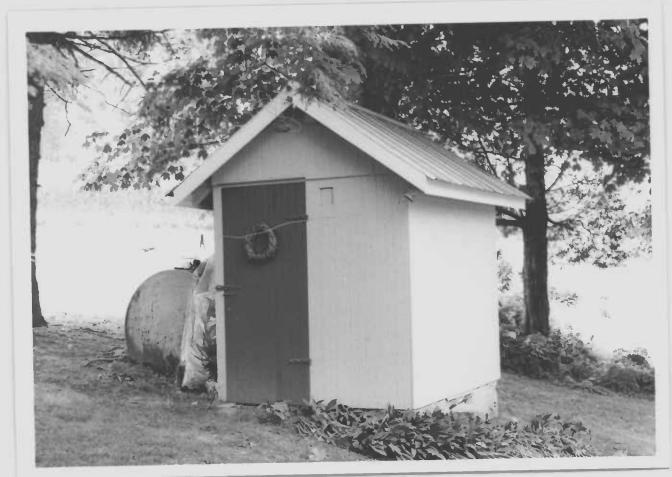
2/8

Smoke nouse - Sa theast in orthogen clevetons

Just northwest of the new house is a smokehouse with a concrete foundation, beaded-edge-and-center vertical board siding, and a gable roof of inverted-V-seam metal with a ridge that runs southeast-northwest. It has a door with strap hinges on the southeast.

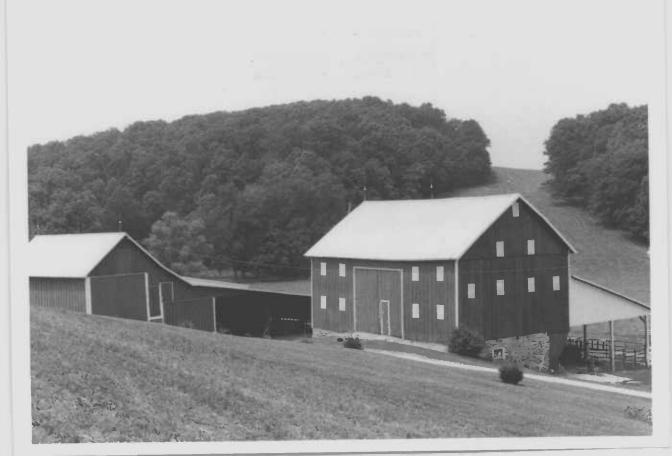
Date; June 1993 barn compex Southwest Southers 3/E

Approximately 40 feet southeast of the wagon shed is a bank barn, with the forebay facing northeast. The barn has a rubble stone foundation, vertical board siding

on the upper story, and a gable roof with inverted-V-seam metal, three lightning rods with blue glass balls, and a northwest-southeast ridge. The lower level of the northeast elevation has been completely opened up. The upper level now has a large, recent shed attached to it. There are two wood-louvered vents at each end. In the center are double doors, on butterfly hinges, above missing double doors. The southeast elevation has a one-light sash in the foundation, with four vents in the upper story, two in the gable end, and one in the peak. The northwest elevation is identical. The southwest elevation has double wagon doors on strap hinges in the center, with two vents over two vents in each side. The lower-story stalls have been altered. There are two summer beams supported by posts underneath the diagonal scarf joints. The joists are hewn top and bottom. The northwest wall has a peg rail set in the stone, and a wood box. The upper story has a center threshing floor, with a hay mow on each side. There is no granary visible. There are also no stairs visible, but there is a hay chute to the stable. The barn has four hewn queen-post-truss bents with pegged mortise-and-tenon joints. Several joints also have metal straps around three sides for additional reinforcement. There are two built-in ladders in the center bents. The rafters are sawn, are about 2x4 inches, and have a ridge piece. They support wood lath and a metal roof.

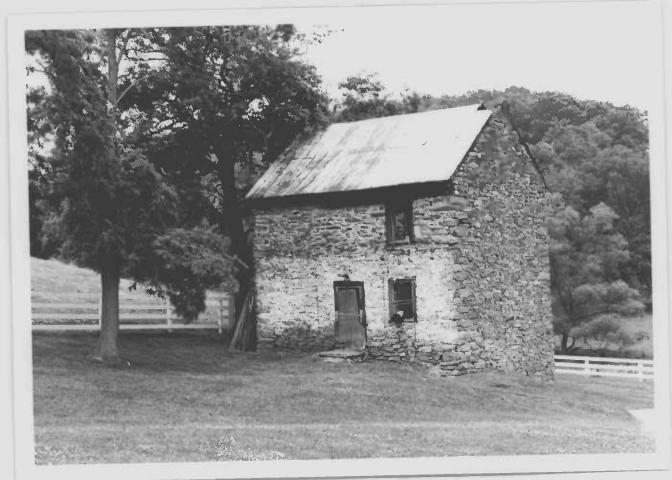
Neg. Loc Margland Historical Trist and home southwest southeast elevations 4/8

About three hundred feet northwest of the new house is the old stone house. This is a three-bay by one-bay, two-story banked building with an exposed cellar wall on the northeast. It is built of rubble stone, with rough quoining at the corners, and has a gable roof with corrugated metal and a ridge running northwest-southeast. The northeast elevation cellar wall has a central door opening flanked by a window opening on either side. The window frames are mortised-and-tenoned and pegged; the door frame is missing. The first story has a center door opening that was later enclosed for a 6/? window. The door opening has a large stone sill. None of the openings in the house have lintels. Instead, the rubble stone wall is carried up over the frames. The north bay of the first story has a window opening, as does this bay in the second story. The other bays are blank. There is no evidence, such as pockets for joists or rafters, to suggest there was a porch on this elevation. The box cornice on this elevation is deteriorated.

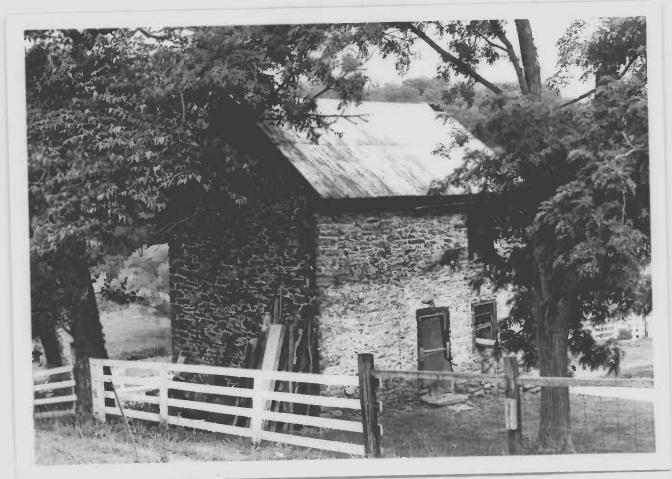
5/4

Arnold Farm 1440 Bellinger Real Carrill Courty, Mary and Photo her leth m Short Date: May 1993 Neg, Loc.: Maryland Historical Trust old house-northeast : southeast elevations

The original window frames throughout the first and second stories are no longer visible since they have been boxed in with boards that are attached with cut nails. The southeast elevation has no openings. It has tapered rake boards and an interior brick chimney centered on the gable. The northwest elevation has one opening, centered in the gable end. The rake boards on this elevation are probably not tapered. The southwest elevation, first-story, has a center-bay door opening. The door is gone, but a cast-iron butt hinge survives. There is nothing in the west bay and a 6/? sash in the south bay.

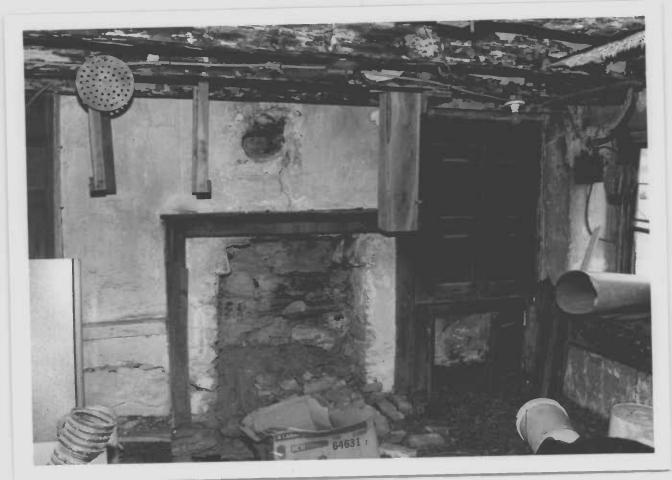
Hinold Farm 140 Bolliger Road Carroll County, Maryland Photo: Her of Short Date: May 1993 Neg. Loc.: Maryland Historical Trest southwast wall old house 1st story 1/8

The first story was originally one room but is now divided by a northeastsouthwest wall set northwest of center. This wall has circular sawn lath and plaster. There is a vertical board door with replaced hinges and a cast iron box lock with porcelain handle in the center of the wall. The door surround is plain, with mitered corners. There is a stone fireplace centered on the southeast wall. It had a brick arch lintel, now mostly collapsed, and a plaster surround. The wood mantel has a beaded interior edge, an ovolo on the outer edge, and a shelf supported by a simple bracket at each end. There is a stove pipe hole cut into the chimney above the mantel. South of the fireplace is a cupboard. The two bottom doors have one panel each, and the two top doors have two panels each. The panels are flush, and the panel moulds were run on the edges of the rails and stiles, not applied. The doors are hung on H-hinges with wrought nails, which are clinched on the inside. The cupboard has a wood surround with a beaded interior edge and an ovolo moulding around the outer edge, identical to the fireplace. The shelf boards inside the cupboard are tongue-and-grooved. East of the fireplace is a tongue-and-groove vertical board door to the cellar stairs. This door is made of three boards, the center of which is narrow and has a bead on either end. The door is hung on cast-iron butt hinges that are nailed. The door surround has a beaded interior edge. East of this door is a second door leading to the winder stairs to the second story. This door is of beaded-edge vertical boards, and the cast-iron butt hinges have screws. The door surround has a beaded interior edge, as well. Both doors are hung with the battens in the room, instead of in the stairway. The baseboard has a beaded top edge. The chair rail has a bead along the bottom edge, and the top shelf has a rounded front edge. The floor is random-width mill-sawn boards. The plaster walls are laid right on the stone, in two coats. The hewn joists of the second story are exposed, and retain traces of white paint on the joists and the bottom of the floor. The

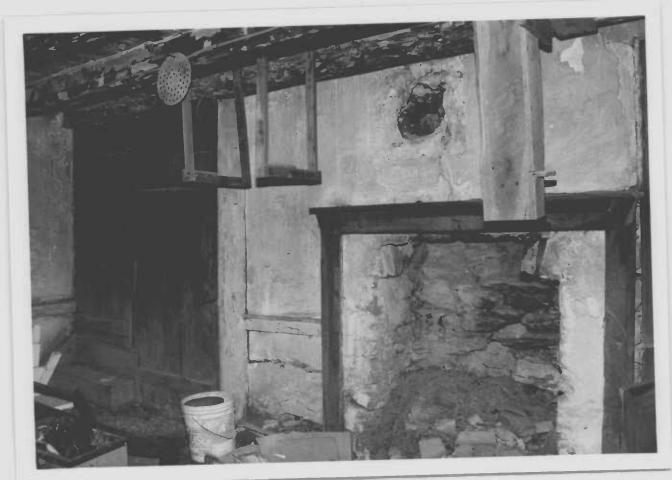
Horold Farm 1446 Pull Prod Cantell County, May plant Pluto: Mencett M. Shat Date: Non 1993 Neg. Loc. Maryland Historical Trust old house jet story surthcost wall

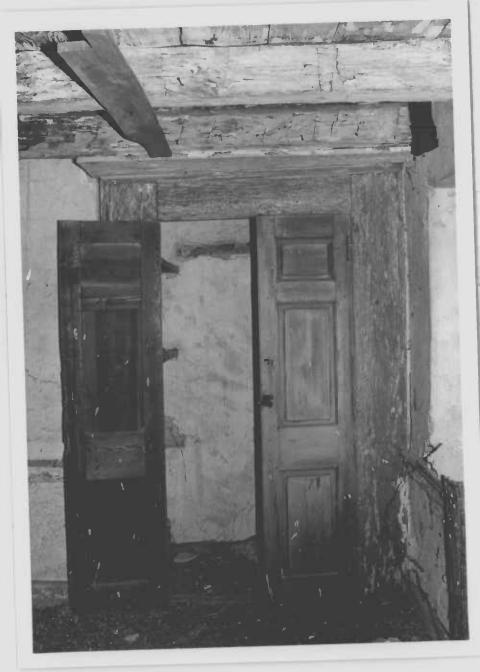
Arrold form 1440 Folloger Mood Carroll County, Maryland Photo: Kenneth 11 Short Date May 1993 Neclaci Maryla & Normal Trust old rouse and Story - Southeast wall

The stair stringer has a beaded top edge like the baseboard. The second story is one room, and has the same chair rail and baseboard as the first story. There is no door to the stairs down, but there is a beaded-edge vertical-board door to the east, leading to the winder stair up to the attic. This door is hung on cast-iron butt hinges with screws. South of the stairs is a chimney that never had a fireplace. South of that is a closet with two large three-panel doors hung on H-hinges with wrought-iron nails. The doors have raised panels, but are otherwise identical in their construction and details to the cupboard below. The surround is the same, as well. The closet has three shelves on the northeast end. The shelves are nailed to the door surround on the northwest side and are set into the stone wall on the southeast side. There was another shelf, or a peg rail, set up high on the southeast wall, to the south of the shelves. The closet wood work retains traces of a grey-green paint. The hewn joists are exposed on the second story retain white paint, and have always been exposed. They are about 4½ inches wide by 6½-7 inches deep, and are spaced 24 inches on center.
